**APPENDIX A – EXISTING ACCESS MANAGEMENT**  
**FIGURES**

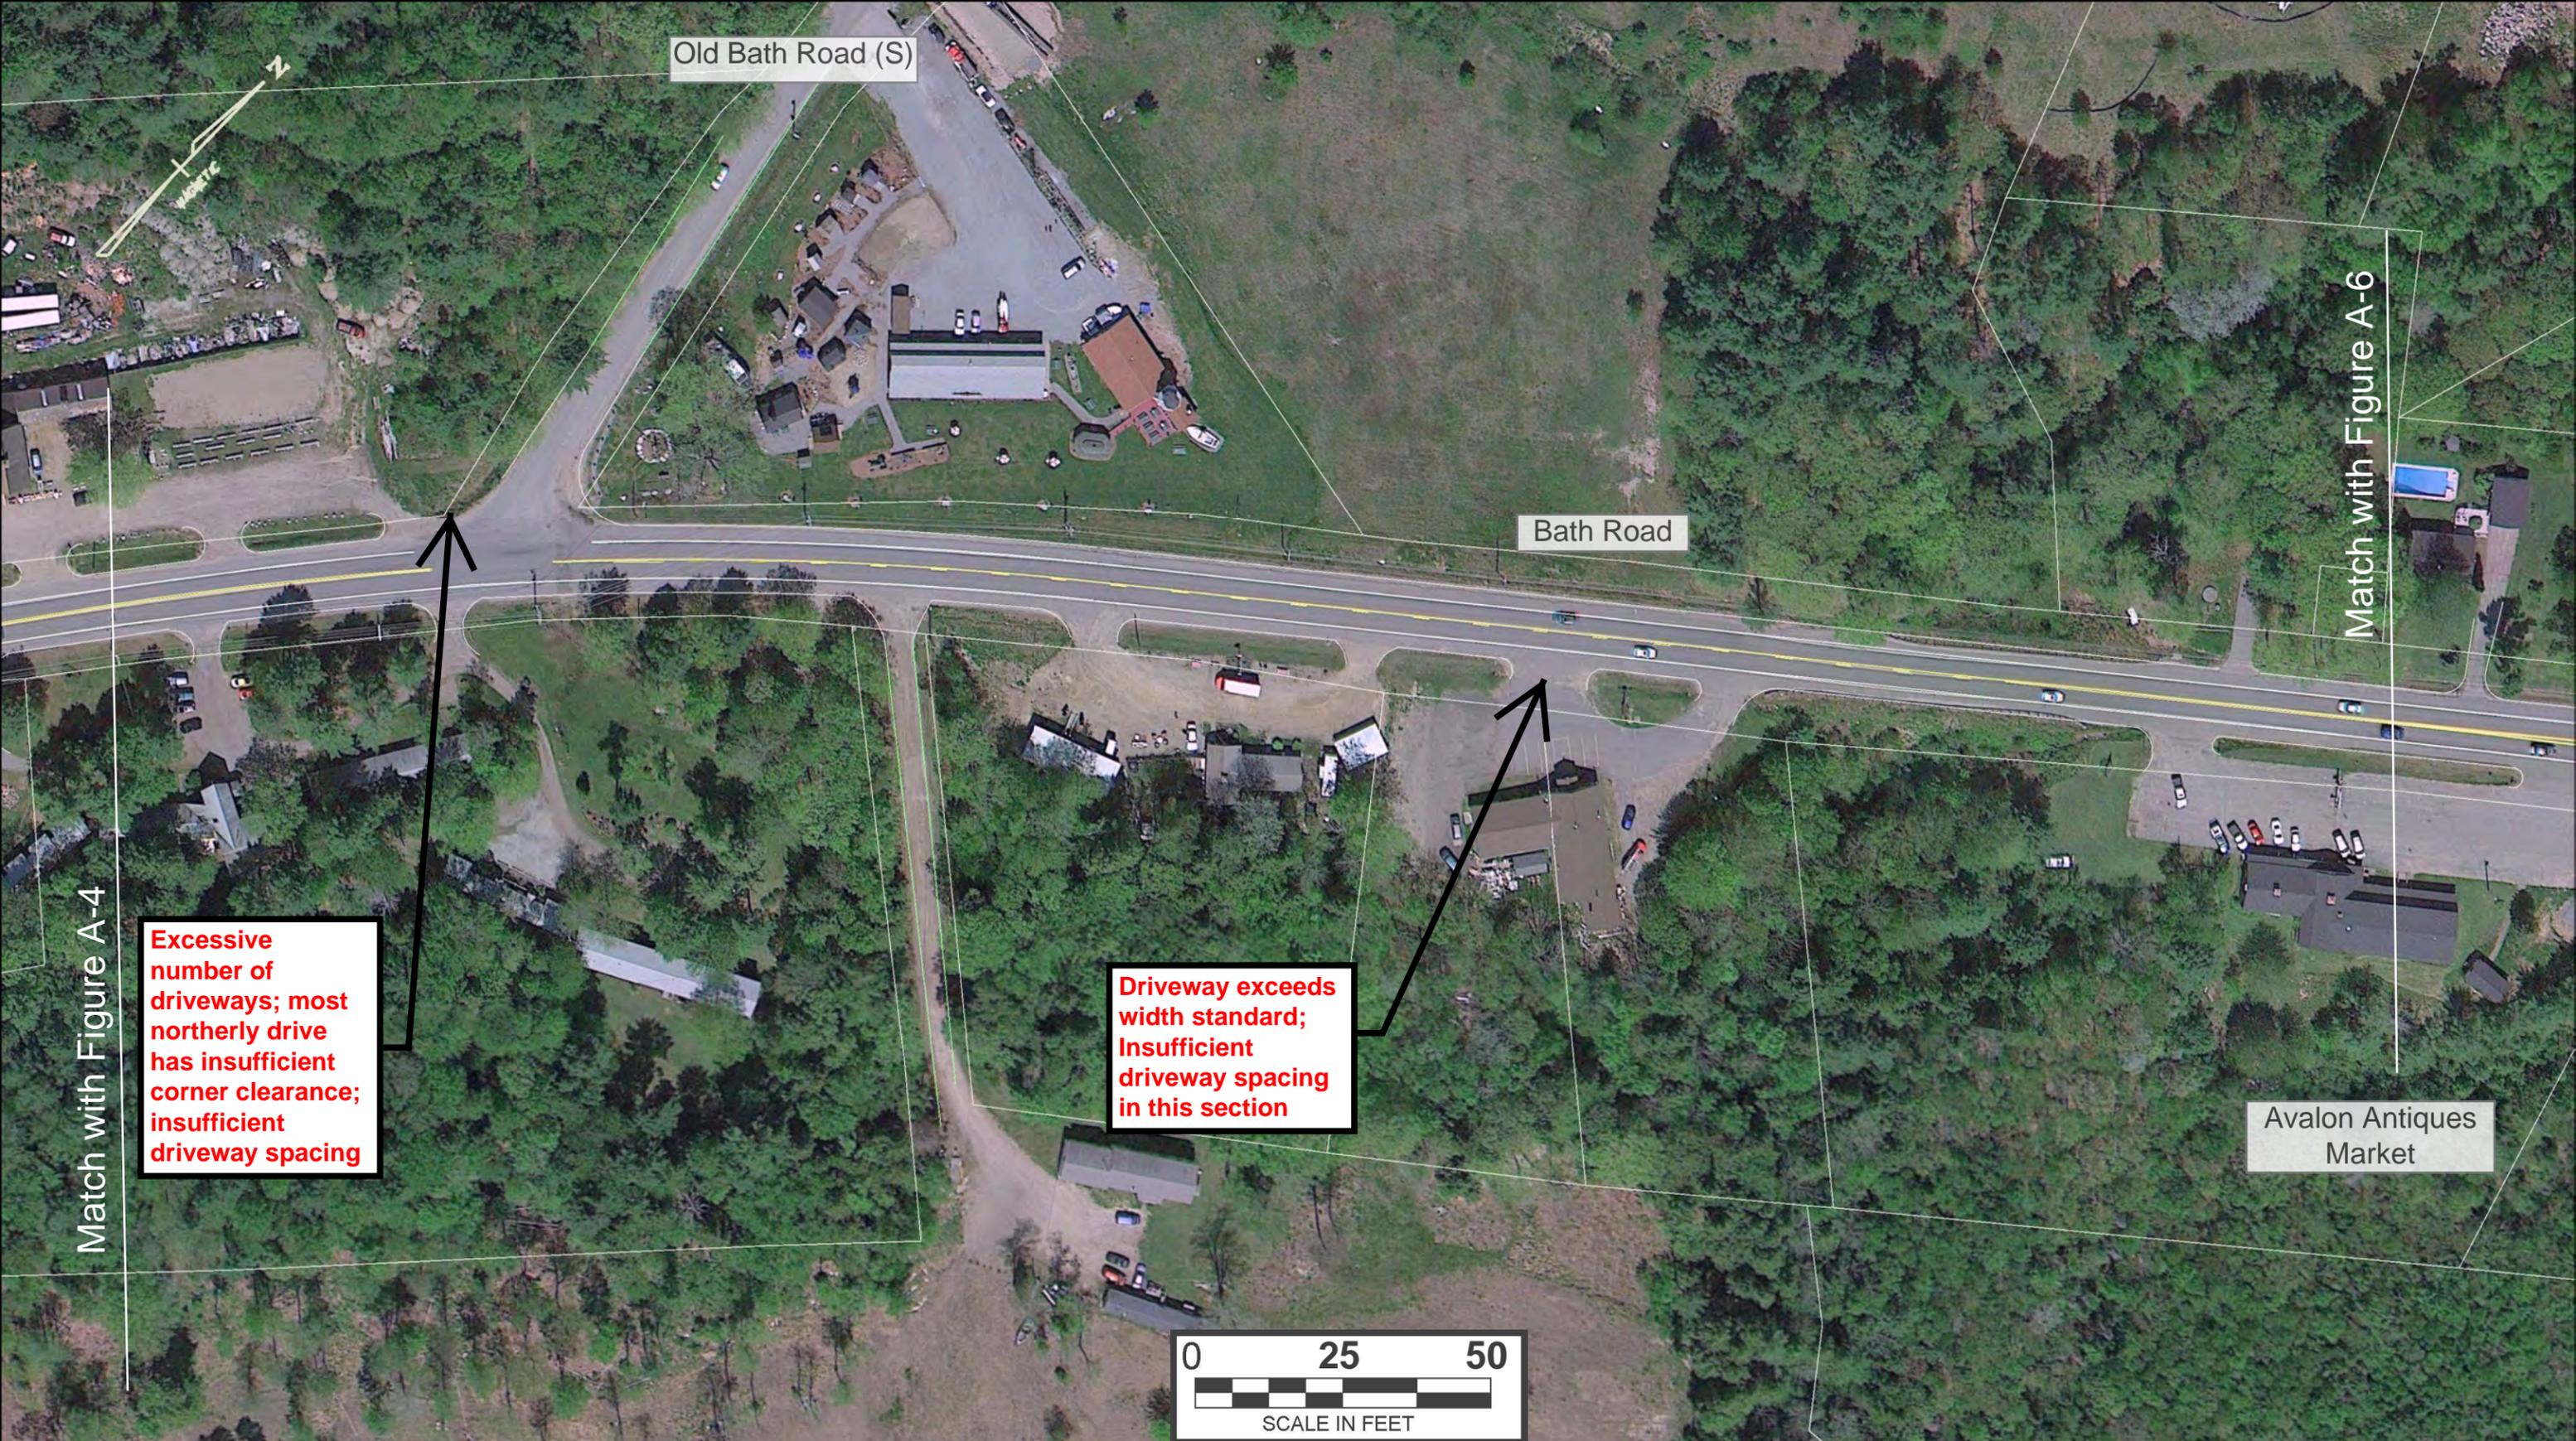
**Figure A-5:**  
*Existing Access Management Conditions*

**Excessive number of driveways; most northerly drive has insufficient corner clearance; insufficient driveway spacing**

**Driveway exceeds width standard; Insufficient driveway spacing in this section**

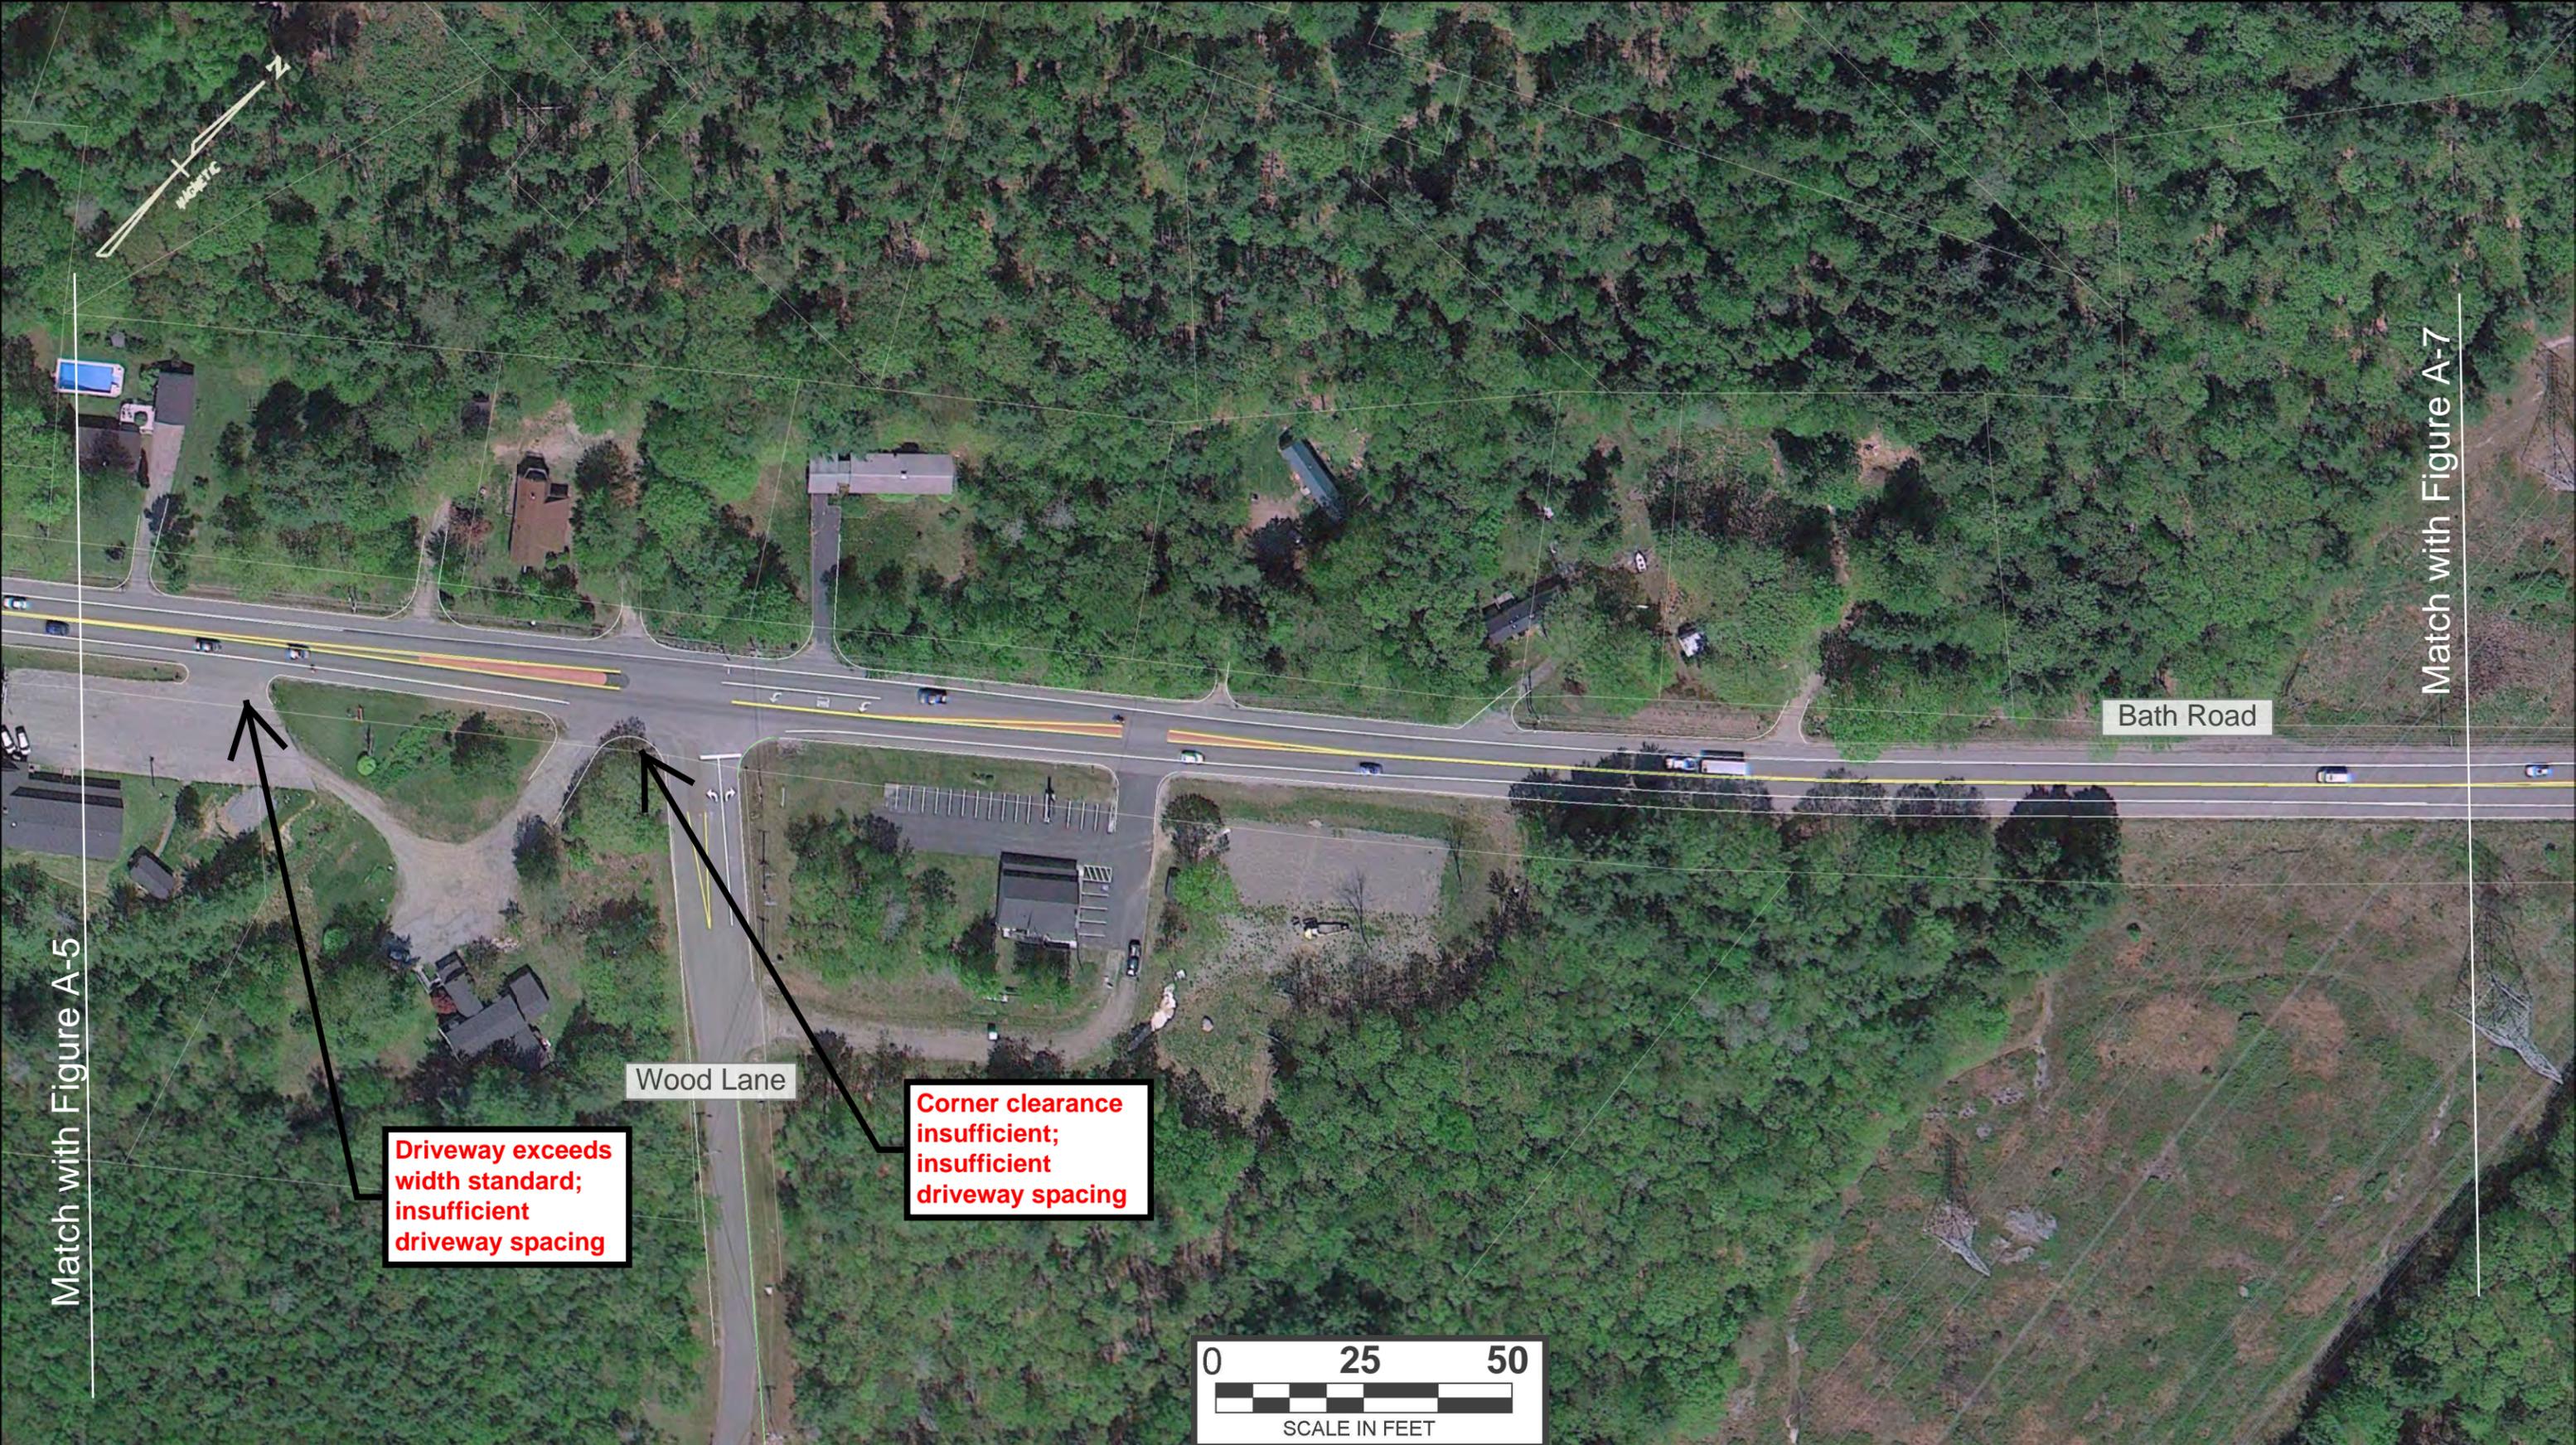
**Driveway exceeds width standard; insufficient driveway spacing**

**Corner clearance insufficient; insufficient driveway spacing**

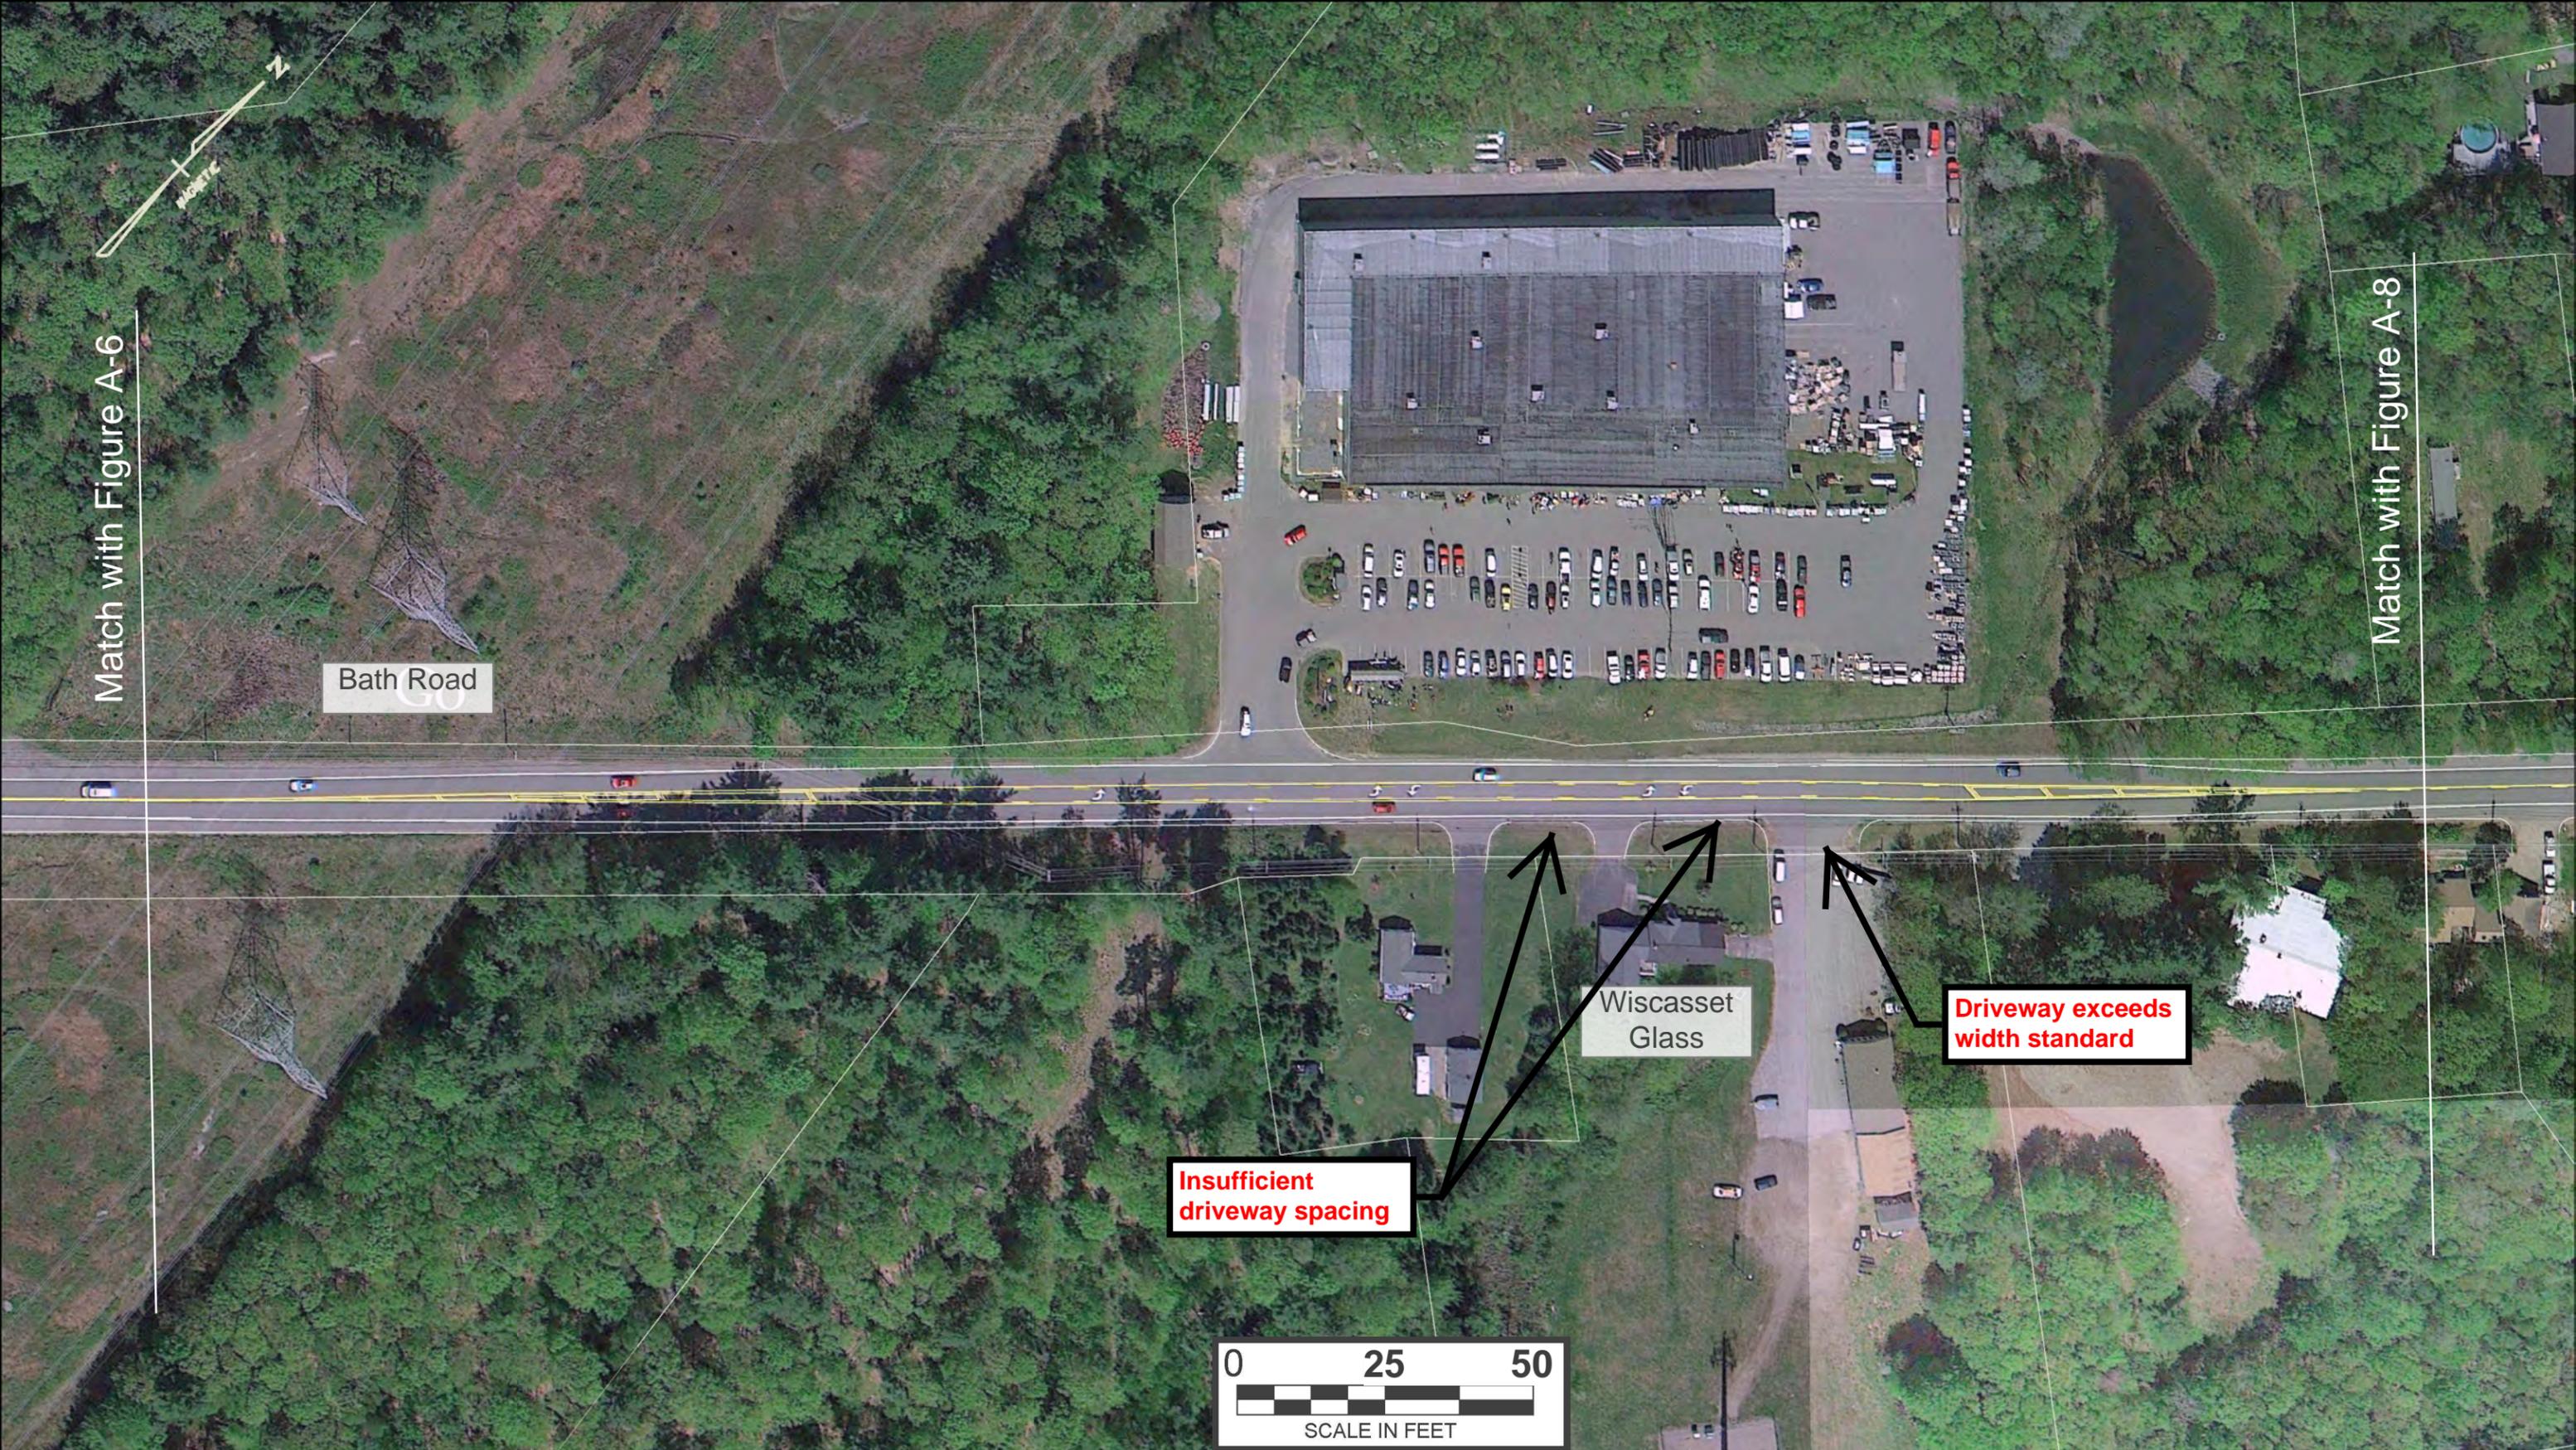
Insufficient driveway spacing

Driveway exceeds width standard
